TEST REPORT

Report No. : SGS-R13-0612-EN
Applicant : GROUND Co., Ltd.
Address : #209, 52 Suntechcity2, Sagimakgol-ro,
 Jungwon-gu, Seongnam-si, Gyeonggi-do, Korea
Product : Third Generation Digital Lightning Protection
 Grounding Device
Model : LM-34-38-90M
Environment : Temp. (23 ± 3) °C, Humidity (37 ± 5) % R.H.
Test Date : May 24, 2013
Standard : MIL-STD-810G: 2008 Method 514.6 (Table 514.6C-VI)
Test Result : Refer to the attached document
Use of report : Validation

Third Generation Digital Lightning Protection Grounding Device / LM-34-38-90M	
TEST ITEM	TEST RESULT
Vibration Test	No abnormal was found.

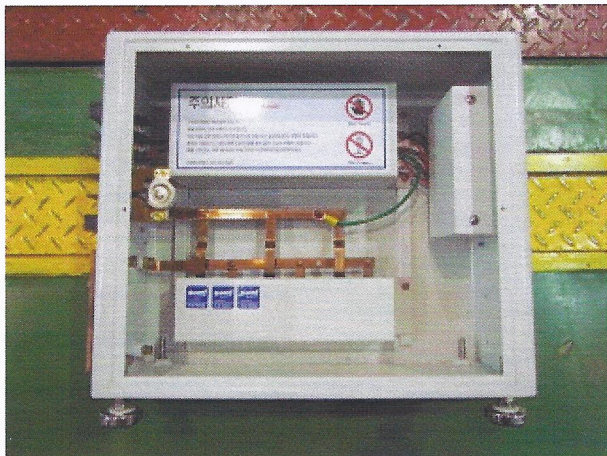
(Before the test)

Check List	Test Result
1. Visual inspection - Mechanical damage such as deformation, separation, loosening of screw, crack, etc.	No abnormal was found.
2. Performance check - Power ON/OFF - LED Lightning	See result photograph (11 page)
