**KOREA TESTING &
RESEARCH INSTITUTE**

Certificate No: CUS2015-1913

3. Test sample : Third Generation Digital Lightning Protection Grounding Device

5. Test method used : MIL-STD-810G : 2008 [Method 514.6]

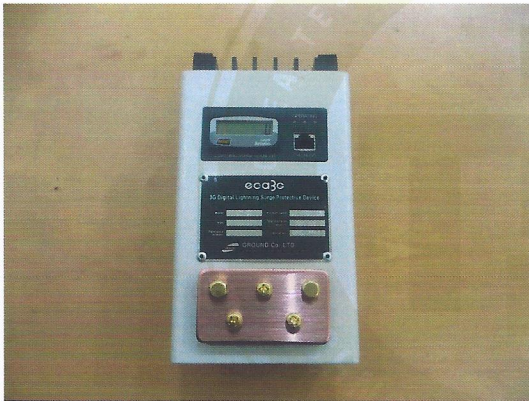
Client : GROUND Co., Ltd
Manufacturer : GROUND Co., Ltd
Product : Third Generation Digital Lightning Protection Grounding Device
Model : LP-3P
Serial No. : AEKELP3P0910
Input voltage : AC 220 V
Sample quantity : 1 EA

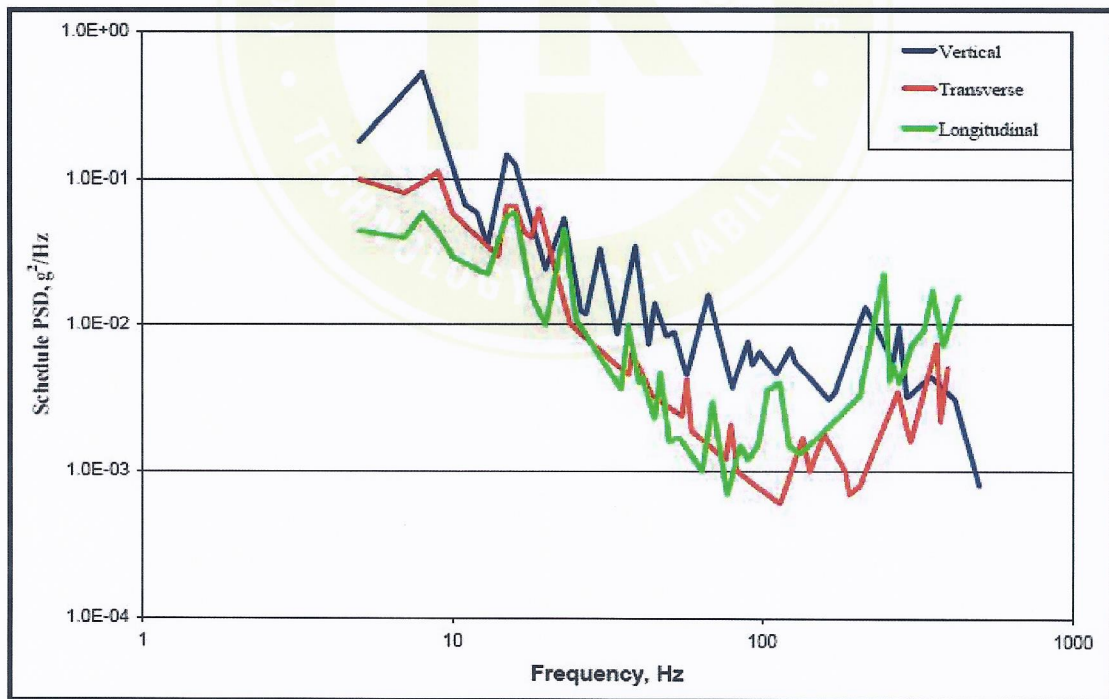
<Vibration Test Profile>

Clause	Contents
Test status of products	<input checked="" type="checkbox"/> Non-operation <input type="checkbox"/> Operation
Test time	<input checked="" type="checkbox"/> Vertical : 2 h <input checked="" type="checkbox"/> Transverse : 2 h <input checked="" type="checkbox"/> Longitudinal : 2 h
Final measurements	<input checked="" type="checkbox"/> Visual inspection : Mechanical damage, loosening of screw, etc.
	<input checked="" type="checkbox"/> Functional test : Lighting check

Vertical		Transverse		Longitudinal	
Frequency (Hz)	PSD (g^2/Hz)	Frequency (Hz)	PSD (g^2/Hz)	Frequency (Hz)	PSD (g^2/Hz)
5	0.175 9	5	0.099 8	5	0.044 1
8	0.512 0	7	0.079 9	7	0.039 0
11	0.066 0	9	0.111 5	8	0.057 6
12	0.058 5	10	0.057 7	9	0.043 0
13	0.034 8	14	0.029 4	10	0.029 3
15	0.144 1	15	0.065 1	13	0.022 1
16	0.123 7	16	0.064 6	15	0.055 8
20	0.024 1	17	0.043 6	16	0.058 5
23	0.053 6	18	0.039 3	18	0.016 0
26	0.012 4	19	0.062 2	20	0.009 9
27	0.011 8	24	0.010 0	23	0.045 2
30	0.033 1	37	0.004 5	25	0.011 0
34	0.008 6	38	0.006 5	35	0.003 6
39	0.034 7	44	0.003 3	37	0.009 8
43	0.007 3	55	0.002 4	40	0.004 0
45	0.014 1	57	0.004 2	41	0.004 4
49	0.008 4	59	0.001 9	45	0.002 3
52	0.008 9	76	0.001 2	47	0.004 7
57	0.004 5	79	0.002 1	50	0.001 6
67	0.016 0	83	0.001 0	54	0.001 7
80	0.003 7	114	0.000 6	64	0.001 0
90	0.007 7	135	0.001 7	69	0.003 0
93	0.005 3	142	0.001 0	77	0.000 7
98	0.006 5	158	0.001 8	85	0.001 5
99	0.006 3	185	0.001 0	90	0.001 2

111	0.004 6	191	0.000 7	97	0.001 5
123	0.006 9	206	0.000 8	104	0.003 6
128	0.005 5	273	0.003 5	114	0.004 0
164	0.003 1	300	0.001 6	122	0.001 5
172	0.003 5	364	0.007 4	132	0.001 3
215	0.013 3	374	0.002 2	206	0.003 3
264	0.005 6	395	0.005 1	247	0.022 6
276	0.009 6	500	0.001 2	257	0.004 1
292	0.003 2	r.m.s. = 1.48 g		264	0.005 4
348	0.004 4			276	0.004 0
417	0.003 1			303	0.007 3
500	0.000 8			332	0.009 2
r.m.s. = 2.24 g				353	0.017 2
				382	0.007 1
				428	0.015 7
				500	0.001 6
				r.m.s. = 1.90 g

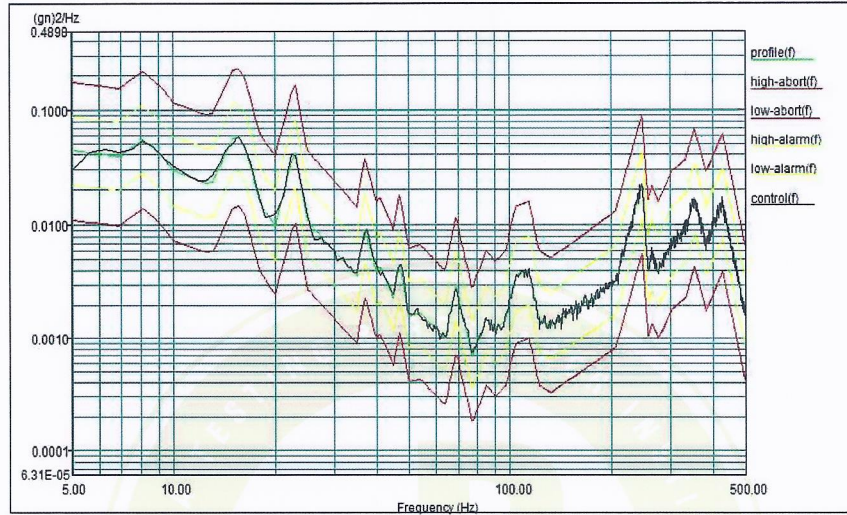
<Vibration test data(Longitudinal)>

DUT:
 Serial Number:
 Project File Name: x축.pri
 Profile Name: Default Test Type: Random Run Folder: RunFolder May 13, 2015 11-38-09

Level: 100 %
 Control RMS: 1.901519 gn Full Level Elapsed Time: 02:00:00 Lines: 800 Frame Time: 1.600000 Seconds
 Demand RMS: 1.898630 gn Remaining Time: 00:00:00 DOF: 154 dE: 0.625000 Hz

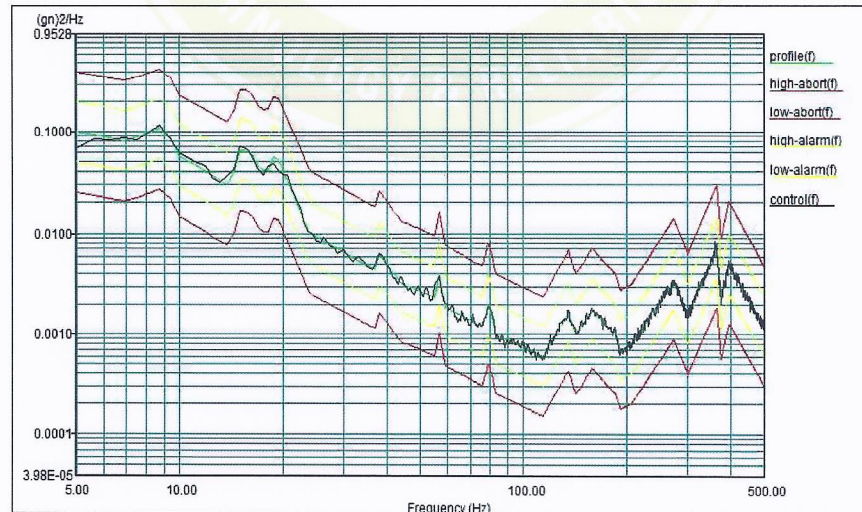
<Vibration test data(Transverse)>

DUT:
 Serial Number:
 Project File Name: y축(RANDOM).pri
 Profile Name: Default Test Type: Random Run Folder: RunFolder May 13, 2015 13-54-37

Level: 100 %
 Control RMS: 1.467062 ga Full Level Elapsed Time: 02:00:00 Lines: 800 Frame Time: 1.600000 Seconds
 Demand RMS: 1.467653 ga Remaining Time: 00:00:00 DOF: 154 dE: 0.625000 Hz

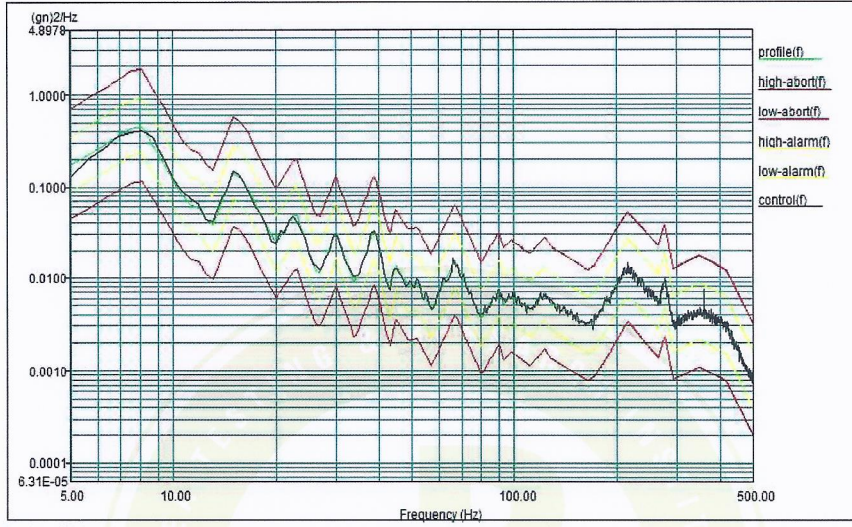
<Vibration test data(Vertical)>

DUT:
Serial Number:
Project File Name: vertical.gvj
Profile Name: Default Test Type: Random Run Folder: RunFolder May 13, 2015 16-42-50

Level: 100 %
Control RMS: 2.239168 gn Full Level Elapsed Time: 02:00:00 Lines: 800 Frame Time: 1.600000 Seconds
Demand RMS: 2.241849 gn Remaining Time: 00:00:00 DOF: 154 dF: 0.625000 Hz
