# TEST REPORT

**Report No.** : SGS-R13-0613-EN  
**Applicant** : GROUND Co., Ltd.  
**Address** : #209, 52 Suntechcity2, Sagimakgol-ro,  
 Jungwon-gu, Seongnam-si, Gyeonggi-do, Korea  
**Product** : Third Generation Digital Lightning Protection  
 Grounding Device  
**Model** : TM-34-20-50M  
**Environment** : Temp. (23 ± 3) °C, Humidity (37 ± 5) % R.H.  
**Test Date** : May 24, 2013  
**Standard** : MIL-STD-810G: 2008 Method 514.6 (Table 514.6C-VI)  
**Test Result** : Refer to the attached document  
**Use of report** : Validation

Third Generation Digital Lightning Protection Grounding Device / TM-34-20-50M	
TEST ITEM	TEST RESULT
Vibration Test	No abnormal was found.

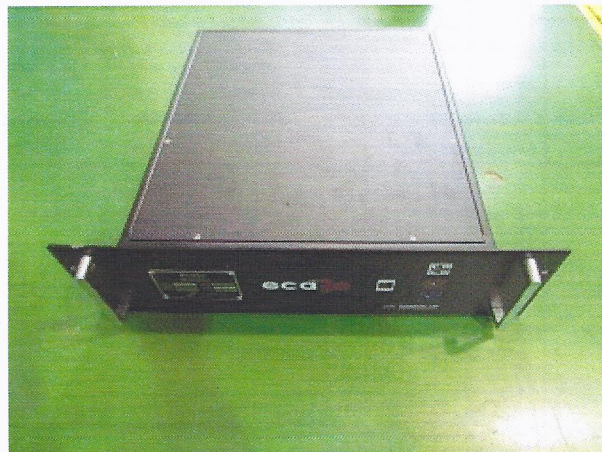
### 2.2 Photograph

- 1) Applicant : GROUND Co., Ltd
- 2) Manufacturer : GROUND Co., Ltd
- 3) Product : Third Generation Digital Lightning Protection Grounding Device
- 4) Model : TM-34-20-50M
- 5) Serial No. : G50TM0000036

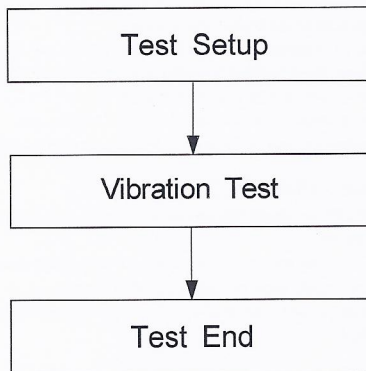
### 3. Test Process

- 1) Perform a visual inspection and an operational check for the specimen.
- 2) Fix the specimen on the vibration table.
- 3) Operate the vibration tester.
- 4) Repeat from steps 2) to step 3) for each required axis.
- 5) Perform a final visual inspection an operational check for the specimen.

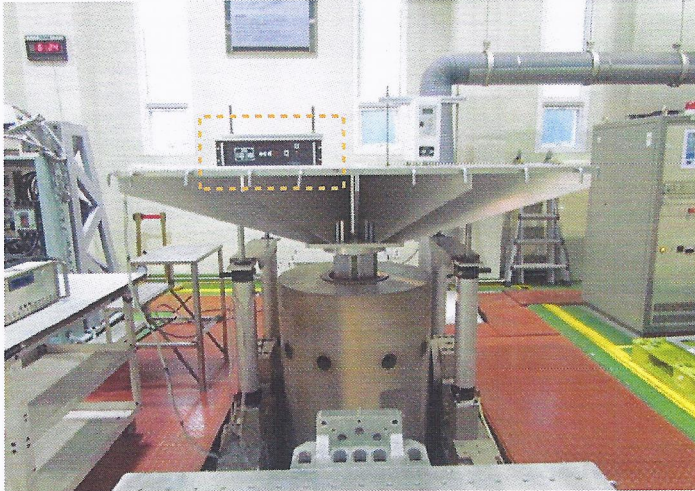
Test axis	Test photograph
Vertical (Z)

- 1) Test type : Random
- 2) Frequency : (5 ~500) Hz
- 3) Acceleration : Z axis - 21.952 m/s<sup>2</sup> r.m.s. (2.24 g<sub>n</sub> r.m.s.)  
 X axis - 15.504 m/s<sup>2</sup> r.m.s. (1.48 g<sub>n</sub> r.m.s.)  
 Y axis - 18.208 m/s<sup>2</sup> r.m.s. (1.96 g<sub>n</sub> r.m.s.)
- 4) Test time : Total 6 h (2 h in each axis)
- 5) Test axis : Vertical (Z), Transverse (X), Longitudinal (Y)
- 6) Check time : Before and After the test
- 7) Sample condition : Unpackaged product / Non-operation
- 8) Sample quantity : 1 EA

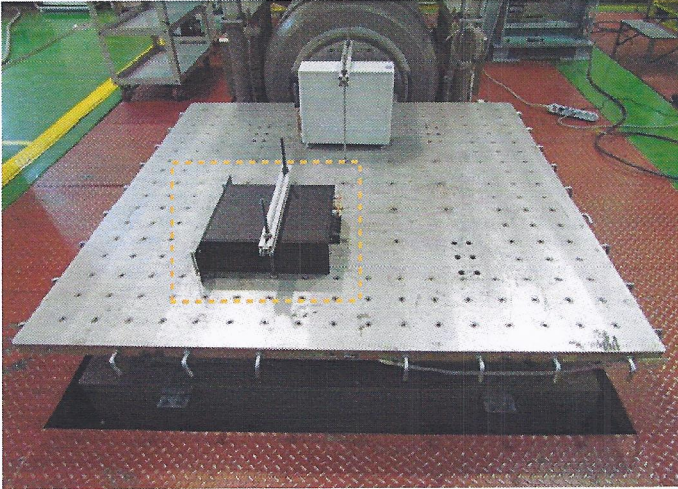
Transverse (X)

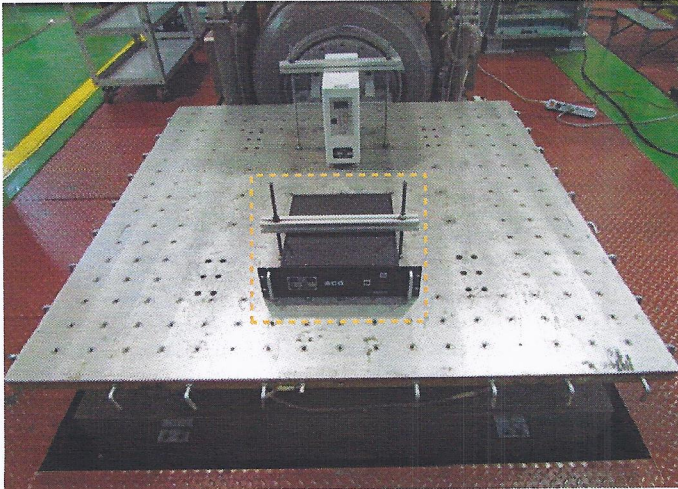
Longitudinal (Y)

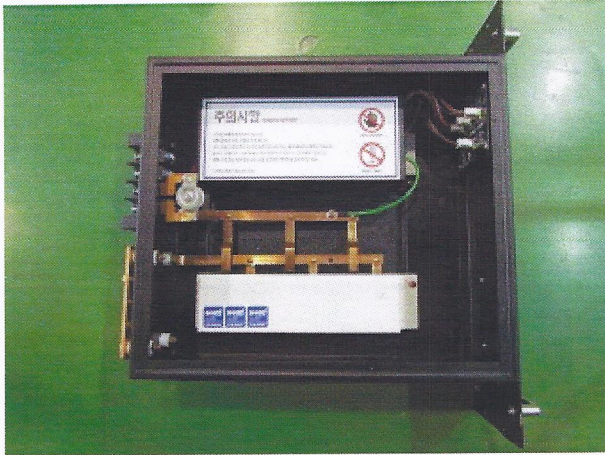
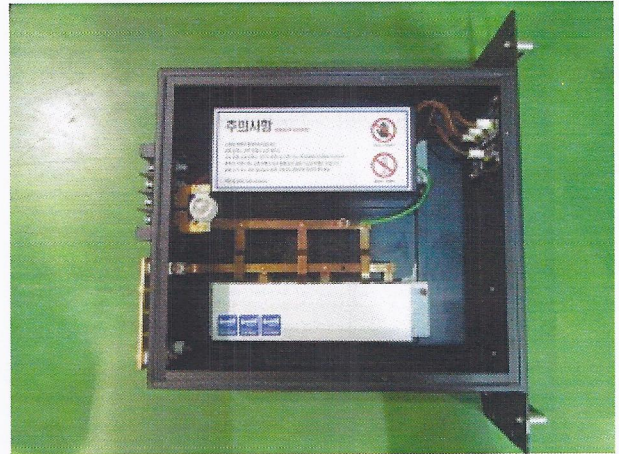
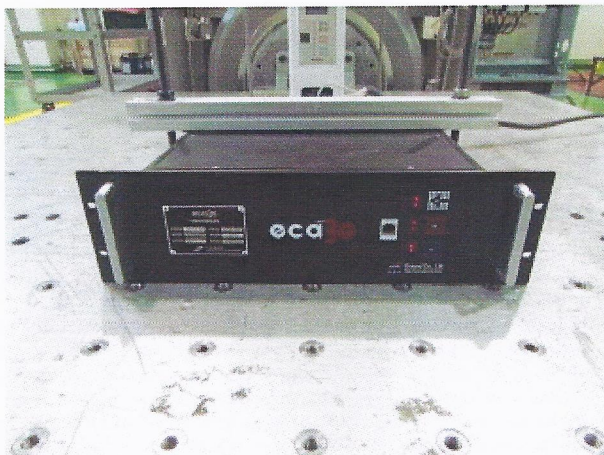
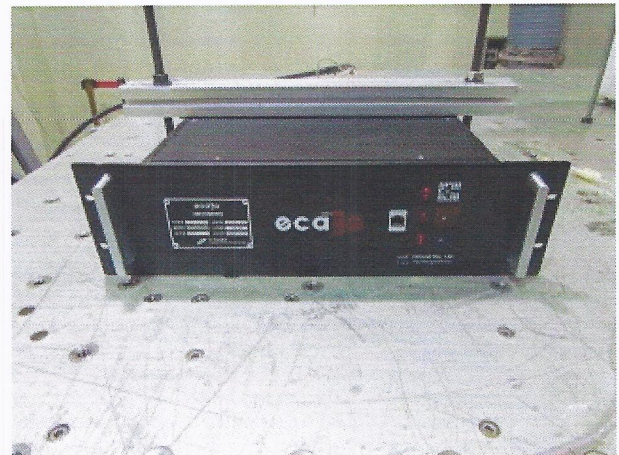
※ Result Photograph

Check List	Test Result
1. Visual inspection - Mechanical damage such as deformation, separation, loosening of screw, crack, etc.	No abnormal was found.
2. Performance check - Power ON/OFF - LED light	See result photograph (11 page)

(Before the test)

(After the test)

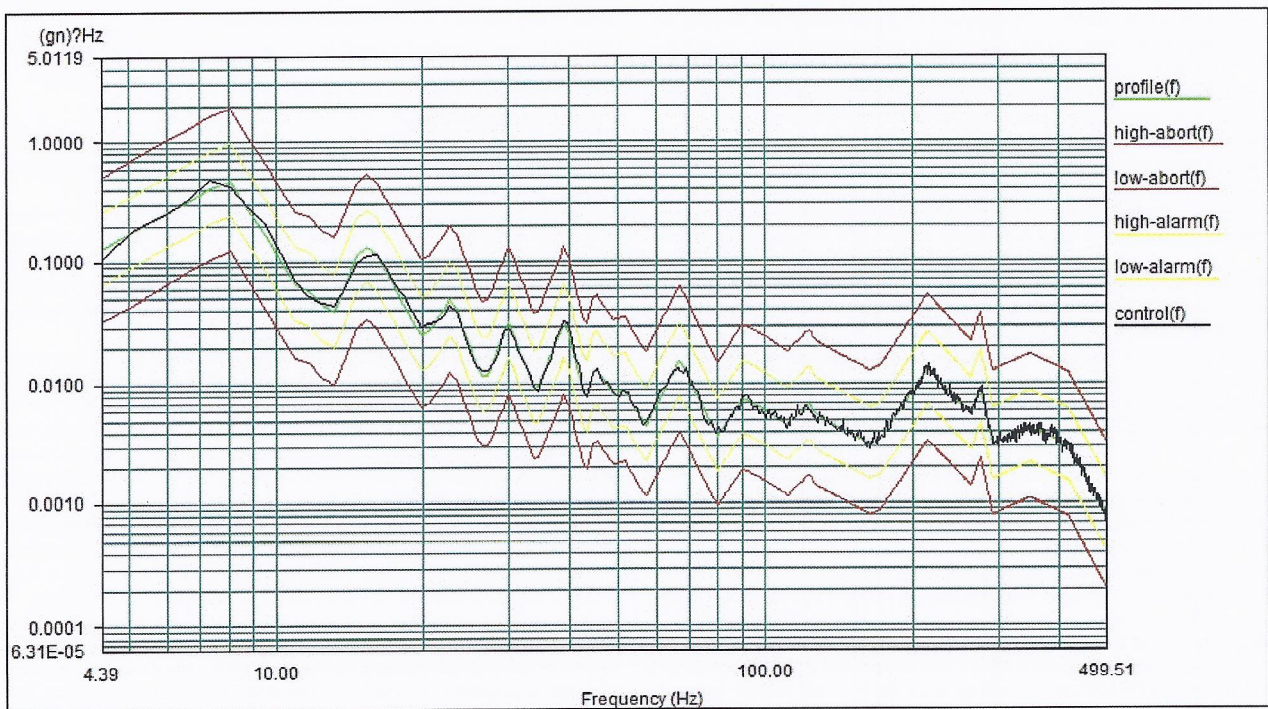
Profile Name: Vibration Test (Z axis)

Test Type: Random

Control RMS: 2.280636 gn

Full Level Elapsed Time: 01:59:59

Demand RMS: 2.254850 gn

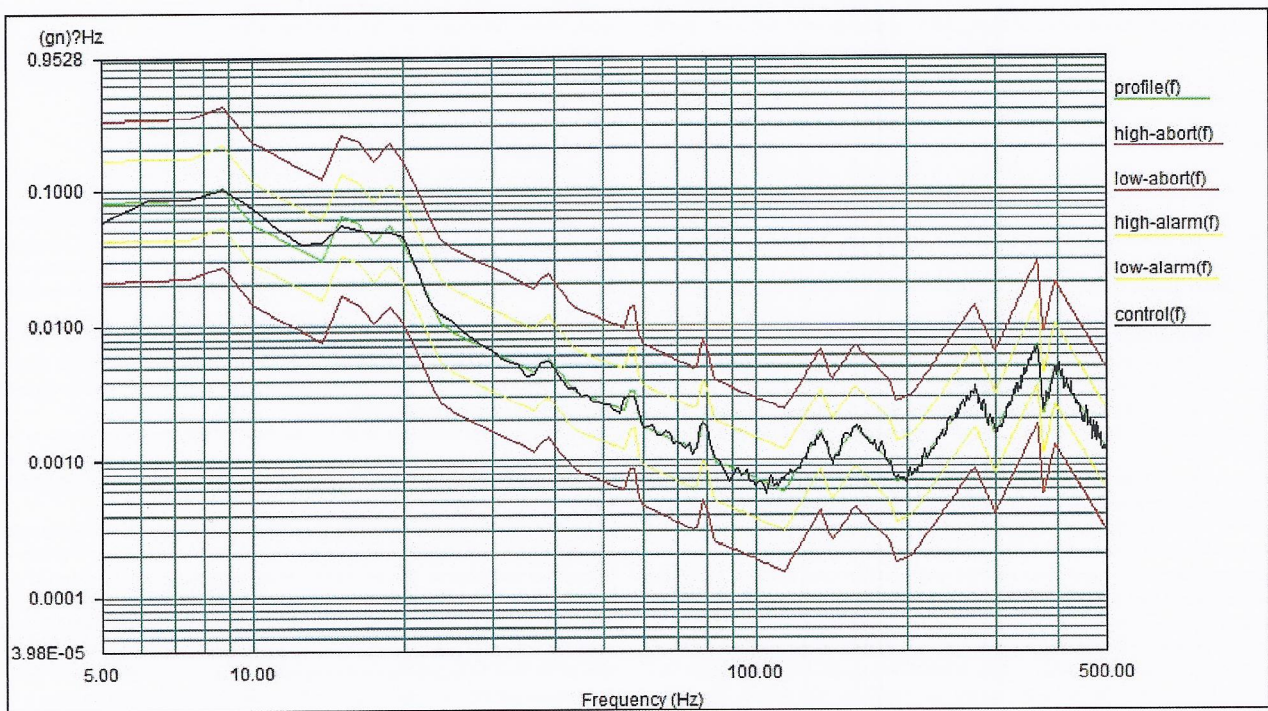
Profile Name: Vibration Test (X axis)

Test Type: Random

Control RMS: 1.492004 gn

Full Level Elapsed Time: 01:59:57

Demand RMS: 1.471470 gn

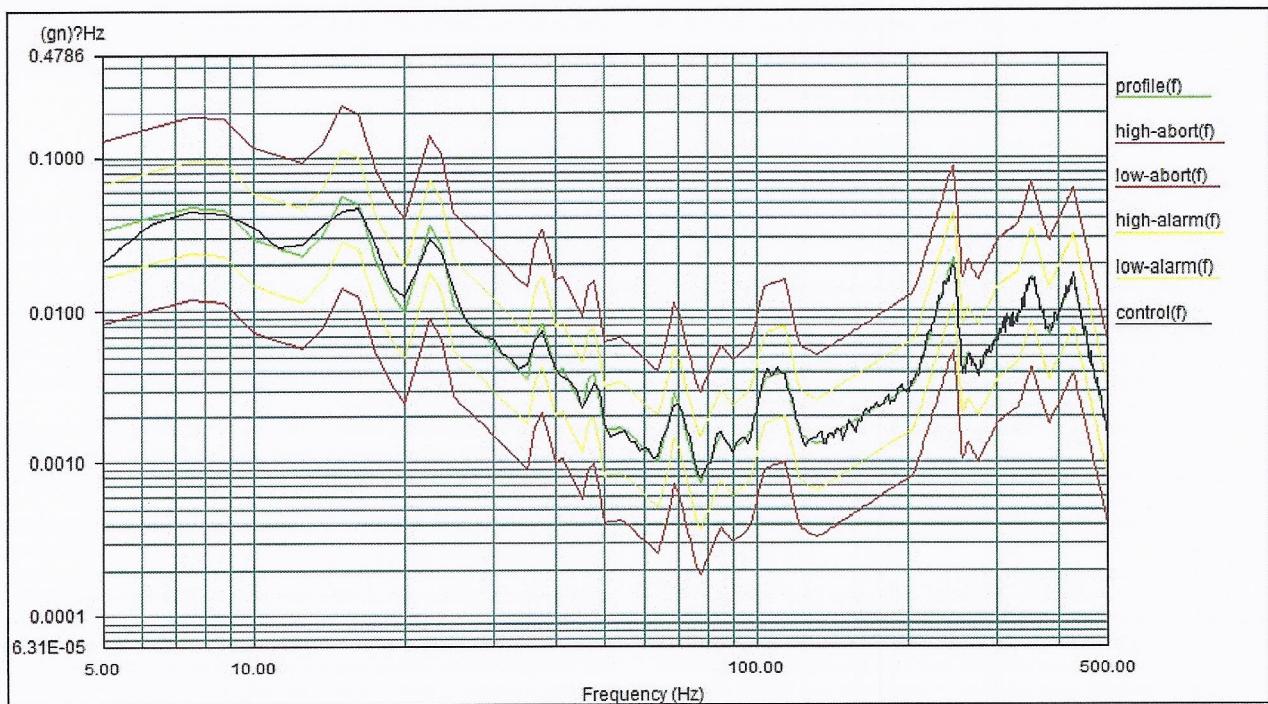
Profile Name: Vibration Test (Y axis)

Test Type: Random

Control RMS: 1.907421 gn

Full Level Elapsed Time: 01:59:54

Demand RMS: 1.898276 gn
