**KOREA TESTING &  
RESEARCH INSTITUTE**

Certificate No: CUS2015-1913

3. Test sample : Third Generation Digital Lightning Protection Grounding Device

5. Test method used : MIL-STD-810G : 2008 [Method 514.6]

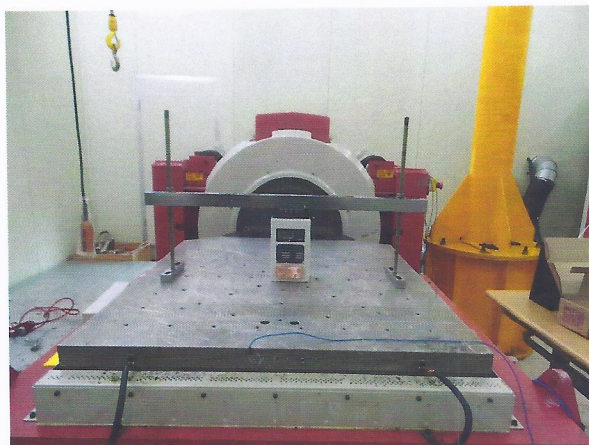
〈Longitudinal〉

## 3.6 Test picture

Vibration direction	Visual inspection	Functional test
Longitudinal	No abnormal was found	Normal Operation
Transverse	No abnormal was found	Normal Operation
Vertical	No abnormal was found	Normal Operation
